# West Hackberry Vegetative Planting Demonstration (CS-19)

## Project Status

**Approved Date:** 1991      **Project Area:** 0 acres  
**Approved Funds:** \$0.25 M      **Total Est. Cost:** \$0.25 M  
**Net Benefit After 20 Years:** 0 acres  
**Status:** Completed March 1994  
**Project Type:** Demonstration: Vegetative Planting and Sediment Trapping

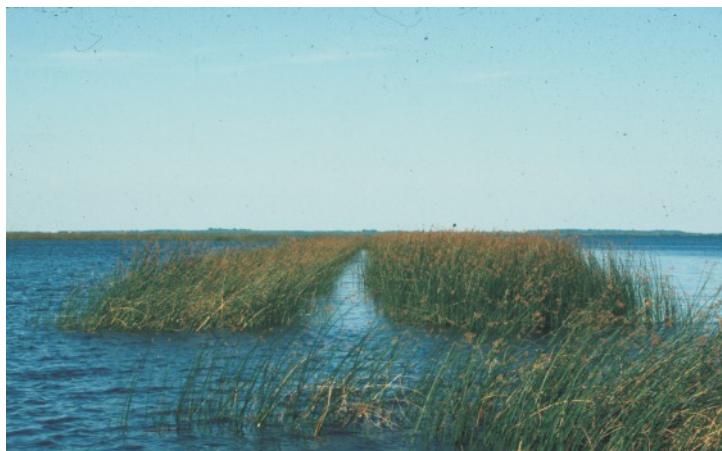
California bulrush plantings after prolonged exposure to elevated salinity levels.

California bulrush plantings were initially successful, creating 4.3 acres of emergent vegetation that formed an effective wave buffer. However, following droughts in 1996 and 1999-2000, less than 1.2 acres survived. During the drought of 1996, salinity levels rarely fell below 20 parts per thousand (ppt) for six weeks, and salinity levels averaged 15 to 20 ppt for the period of drought in 1999 to 2000. Prolonged exposure to these extreme conditions exceeds the typical salinity tolerance of California bulrush. Nevertheless, some plants did manage to survive the droughts and eventually showed gain in lateral spread, although thinning within the plots was noted.

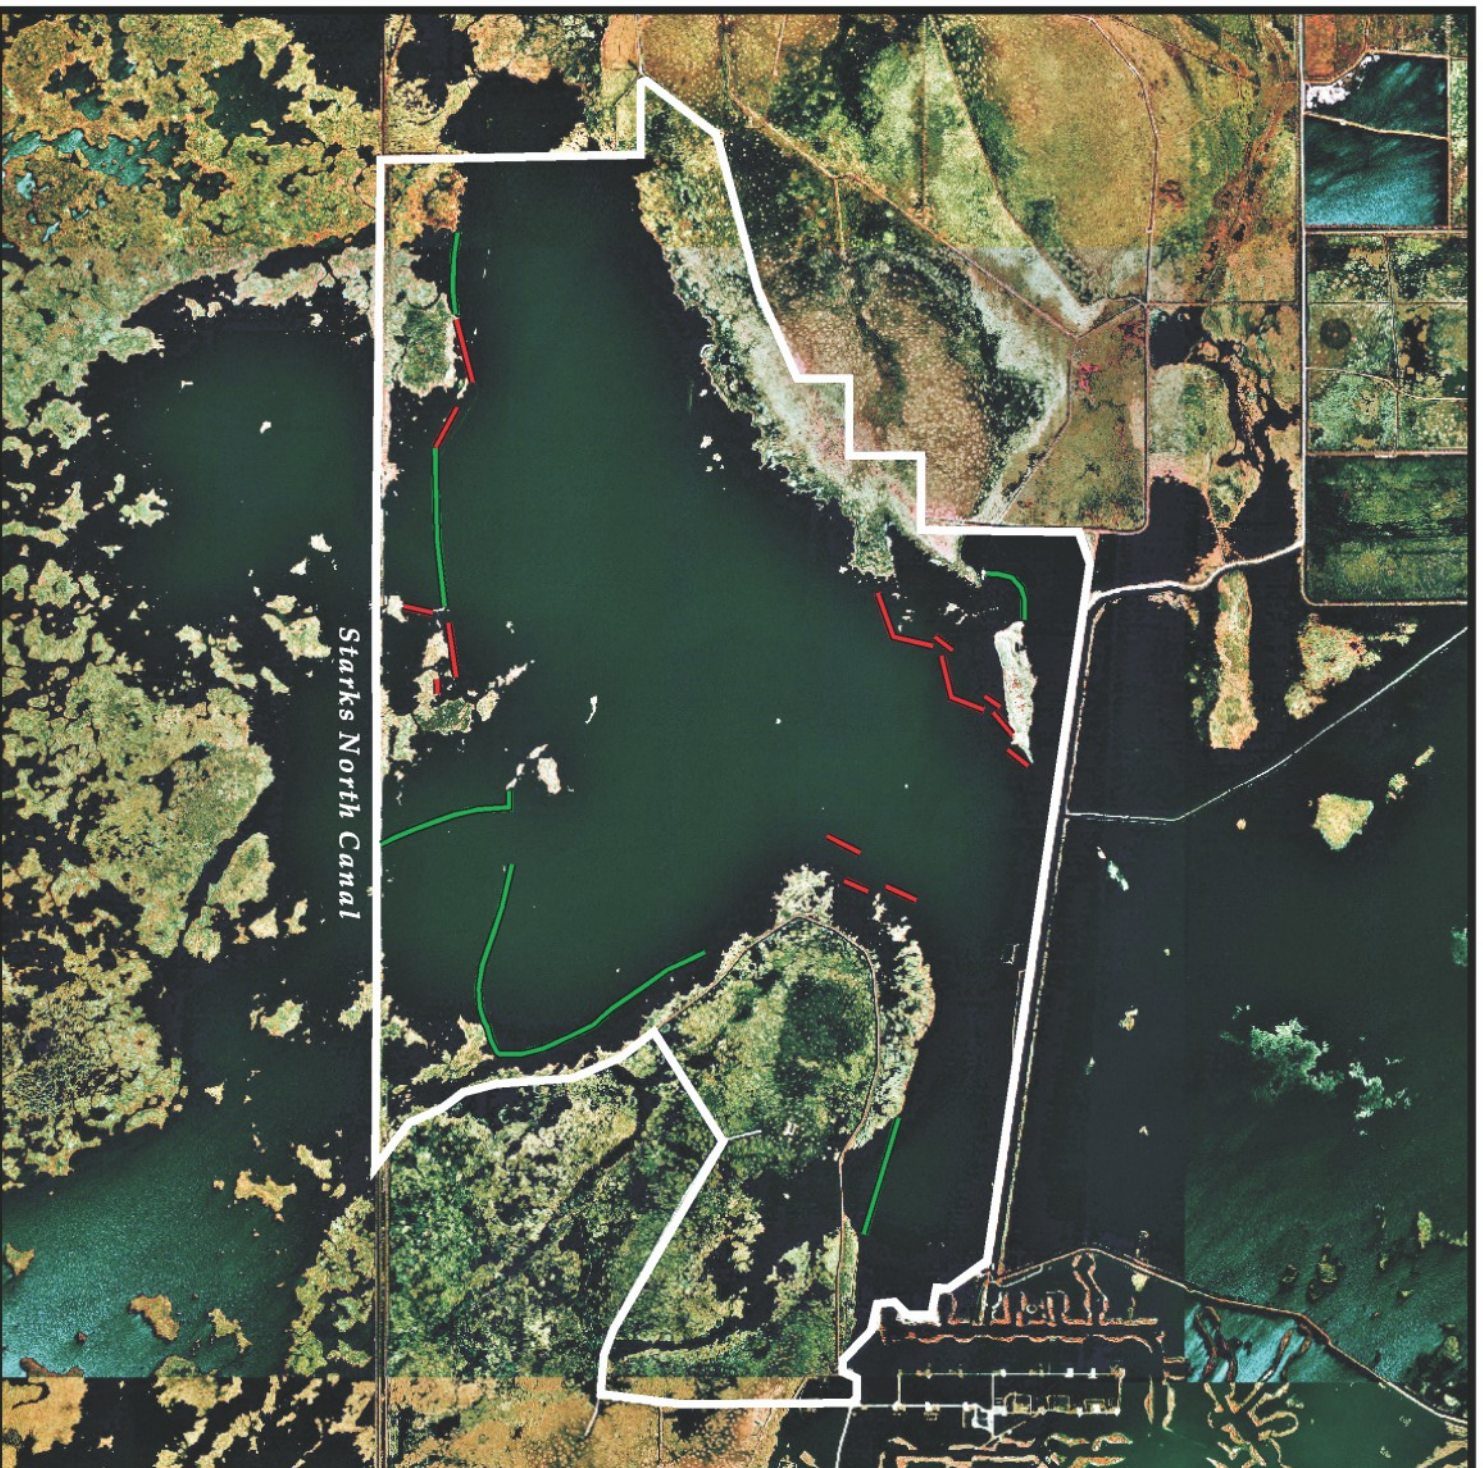
# West Hackberry Vegetative Planting Demonstration (CS-19)

-   Vegetative Planting
-   Sediment Fence
-   Project Boundary

In April 1994, 6,000 linear feet of hay-bale fencing segments were constructed parallel to the project area shorelines in an effort to reduce erosion from wind-induced wave energy, and increase the amount of sediment deposition.

In June 1994, 4,750 California bulrush (*Schoenoplectus californicus*) plants were installed along 11,875 linear feet of marsh shoreline to protect against wave erosion.
